HISTORIC RESOURCE INVENTORY FORM Resource Address: 1226 Amarillo St Abilene Texas 79602 United States County: Taylor Historic name: Jones/Holly House Present name: Jones/Holly House Local place name: Visible from public right of way: Yes Ownership: Private Owner/Address: Land unit size: Site/Setting: **Historical Information** Historic Function: Domestic: Single Dwelling Construction Date: ca. 1920-1929, 1920* Original or Significant Owners: Significant Date/Period: Areas of Significance: **Architectural Information** Category: building, domestic building Structural: balloon frame Е

Survey and Recorder		
Project: City of Abilene - Historic Buildings and Districts	Sequence/Key no.: 19	Survey Date: 10/20/11
Prepared By: Abrigg	Report Title/Name: Texas SHPO Grant to update existing Survey	Previous Surveys:
Inventoried: 10/15/2012 10:13:49 am Last updated: 01/04/2017 10:15:29 am by Hayden Brodowsky /	Level of Survey: ✓ Reconnaissance Intensive	Additional Research Recommended? ✓ Yes No

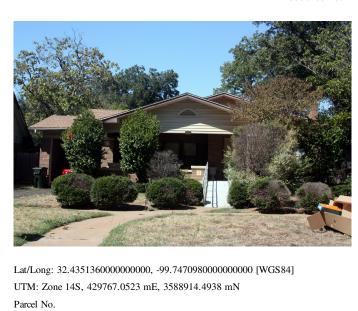
This is a 1-story, 3-bay domestic building in the Craftsman style built in 1920. The structural system is balloon frame. The foundation is undetermined. Exterior walls are original brick and original wood siding. The building has a cross gable roof clad in replacement asphalt shingles with box cornice. Windows are replacement aluminum, 1/1 double-hung sashes. There is a single-story, two-bay open porch characterized by a gabled roof clad in asphalt shingles with square brick posts.
