# HISTORIC RESOURCE INVENTORY FORM

**818 Cedar St  
Abilene Texas 79601 United States**

Historic name: Copper/Jimenez House

Project: City of Abilene - Historic Buildings and Districts	Sequence/Key no.: 50	Survey Date: 10/2011
Prepared By: Hill	Report Title/Name: Texas SHPO Grant to update existing Survey	Previous Surveys:
Inventoried: 10/22/2012 9:38:03 am Last updated: 01/06/2017 10:00:14 am by Hayden Brodowsky /	Level of Survey: <input checked="" type="checkbox"/> Reconnaissance <input type="checkbox"/> Intensive	Additional Research Recommended? <input type="checkbox"/> Yes <input type="checkbox"/> No

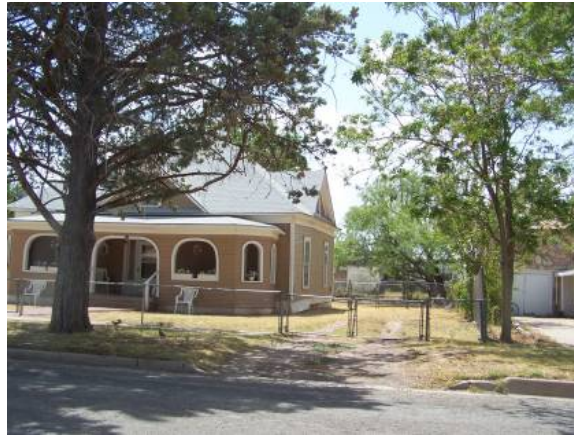
This is a 1.5-story, 3-bay domestic building in the Eastlake/Folk Victorian style with Late Victorian influences built in 1925. The structural system is undetermined. The foundation is undetermined. Exterior walls are original wood siding. The building has a hipped gable roof clad in replacement asphalt shingles. Windows are , 1/1 double-hung sashes. There is a full-span enclosed porch characterized by a hip-and-gable roof clad in asphalt shingles with arcaded arch posts.
