HISTORIC RESOURCE INVENTORY FORM

Resource Address:
710 Meander St
Abilene Texas 79601 United States

Historic name: Clark/Boyce House

Project: City of Abilene - Historic Buildings and Districts	Sequence/Key no.: 220	Survey Date: 11/2011
Prepared By: Abrigg	Report Title/Name: Texas SHPO Grant to update existing Survey	Previous Surveys:
Inventoried: 10/22/2012 12:40:57 pm Last updated: 04/11/2017 9:15:46 am by Hayden Brodowsky /	Level of Survey: <input checked="" type="checkbox"/> Reconnaissance <input type="checkbox"/> Intensive	Additional Research Recommended? <input checked="" type="checkbox"/> Yes <input type="checkbox"/> No

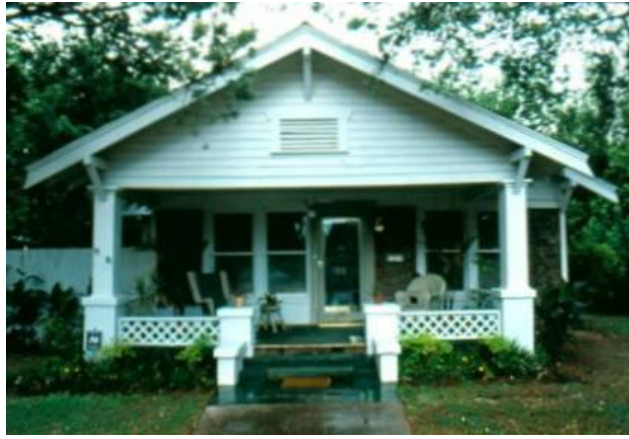
1996

This is a 1-story, 1-bay domestic building in the Craftsman style built in 1927. The structural system is frame. The foundation is undetermined. Exterior walls are original wood siding. The building has a medium front gable roof clad in replacement asphalt shingles with open cornice , gable brackets. Windows are replacement double-hung sashes. There is a single-story, full-span open porch characterized by a gabled roof clad in asphalt shingles with square wood posts on square brick piers.
