HISTORIC RESOURCE INVENTORY FORM

Resource Address:
710 Meander St
Abilene Texas 79601 United States

Historic name: Clark/Boyce House

Project: City of Abilene - Historic Buildings and Districts	Sequence/Key no.: 220	Survey Date: 11/2011
Prepared By: Abrigg	Report Title/Name: Texas SHPO Grant to update existing Survey	Previous Surveys:
Inventoried: 10/22/2012 12:40:57 pm Last updated: 04/11/2017 9:15:46 am by Hayden Brodowsky /	Level of Survey: <input checked="" type="checkbox"/> Reconnaissance <input type="checkbox"/> Intensive	Additional Research Recommended? <input checked="" type="checkbox"/> Yes <input type="checkbox"/> No

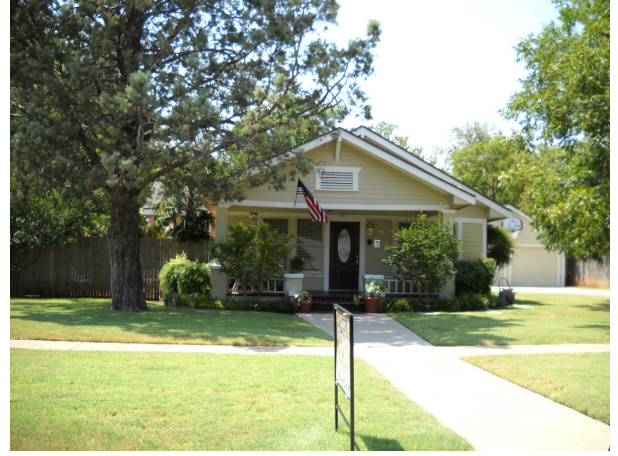
This is a 1-story, 1-bay domestic building in the Craftsman style built in 1927. The structural system is frame. The foundation is undetermined. Exterior walls are original wood siding. The building has a medium front gable roof clad in replacement asphalt shingles with open cornice , gable brackets. Windows are replacement double-hung sashes. There is a single-story, full-span open porch characterized by a gabled roof clad in asphalt shingles with square wood posts on square brick piers.
