HISTORIC RESOURCE INVENTORY FORM

Resource Address:
1818 Belmont Blvd
Abilene Texas 79602 United States

Historic name: Harris/Mullins House

Project: City of Abilene - Historic Buildings and Districts	Sequence/Key no.: 38	Survey Date: 11/2011
Prepared By: Parker	Report Title/Name: Texas SHPO Grant to update existing Survey	Previous Surveys:
Inventoried: 10/16/2012 2:41:27 pm Last updated: 01/05/2017 10:58:22 am by Hayden Brodowsky /	Level of Survey: <input checked="" type="checkbox"/> Reconnaissance <input type="checkbox"/> Intensive	Additional Research Recommended? <input checked="" type="checkbox"/> Yes <input type="checkbox"/> No

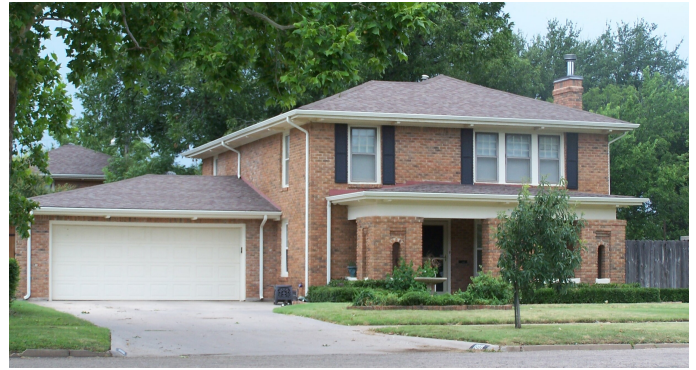
This is a 2-story, 4-bay domestic building in the Prairie School style built in 1930. The structural system is undetermined. The foundation is undetermined. Exterior walls are original brick. The building has a medium hip roof clad in replacement asphalt shingles with box cornice , brackets. There is one side right, exterior, brick chimney. Windows are original wood, 9/1 double-hung sashes. There is a full-span open porch characterized by a hip roof clad in asphalt shingles with paired brick posts on square brick piers. Porte Cochere filled in for 2 car garage in 1990s.
