HISTORIC RESOURCE INVENTORY FORM

**133 Cedar St
Abilene Texas 79601 United States**

Historic name: Commercial Building

Project: City of Abilene - Historic Buildings and Districts	Sequence/Key no.: 47	Survey Date: 10/2011
Prepared By: Hill	Report Title/Name: Texas SHPO Grant to update existing Survey	Previous Surveys:
Inventoried: 10/22/2012 8:38:26 am Last updated: 04/10/2017 5:41:19 pm by Hayden Brodowsky /	Level of Survey: <input checked="" type="checkbox"/> Reconnaissance <input type="checkbox"/> Intensive	Additional Research Recommended? <input checked="" type="checkbox"/> Yes <input type="checkbox"/> No

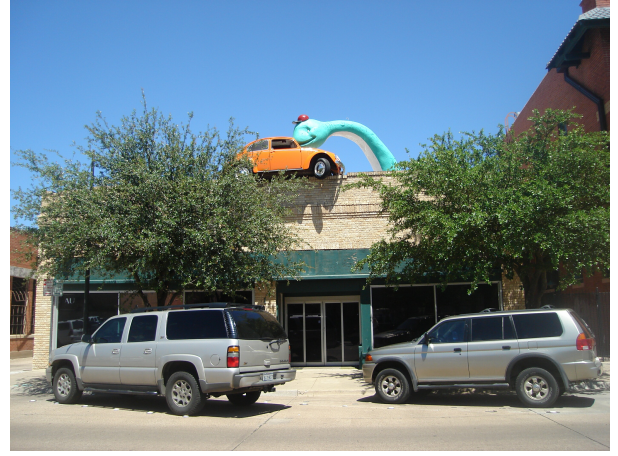
General condition: Excellent

This is a 1-story, 3-bay commercial building in the Moderne style with Art Deco influences built in 1935. The structural system is undetermined. The foundation is undetermined. Exterior walls are replacement glass curtain wall steel frame. The building has a flat with parapet roof. Windows are replacement fixed.

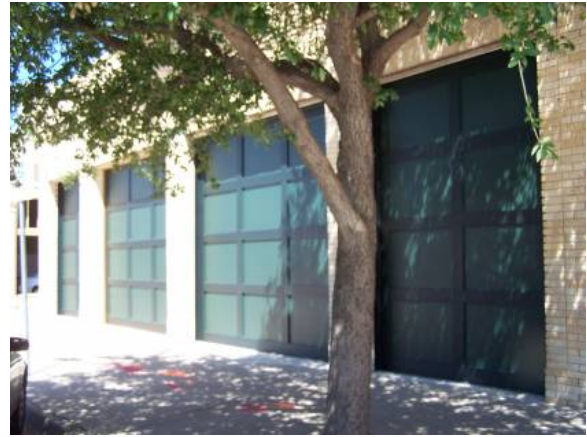
With shutters down

... Form for the Abilene Commercial District. "Although a historic building, building is classified Noncontributing because of insensitive changes to front facade; historic character compromised; could be reclassified if sensitive restoration efforts are completed in compliance with Secretary of Interior Standards for Rehabilitation."
