HISTORIC RESOURCE INVENTORY FORM

Resource Address:
**158 Cypress St
Abilene Texas 79601 United States**

Historic name: Compton Building

Project: City of Abilene - Historic Buildings and Districts	Sequence/Key no.: 80	Survey Date: 2012
Prepared By:	Report Title/Name:	Previous Surveys:
Inventoried: 09/20/2012 12:52:28 pm	Level of Survey:	Additional Research Recommended?
Last updated: 04/10/2017 5:42:26 pm by Hayden Brodowsky /	<input checked="" type="checkbox"/> Reconnaissance <input type="checkbox"/> Intensive	<input checked="" type="checkbox"/> Yes <input type="checkbox"/> No

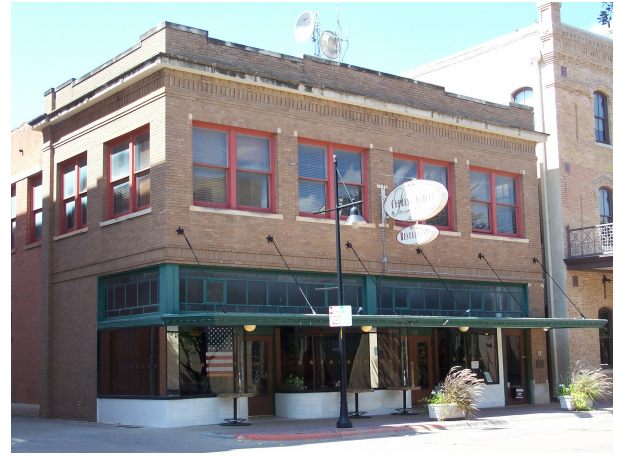
This is a 2-story, 4-bay commercial building in the Late Victorian style with 19th Century Commercial influences built in 1923. The structural system is wood platform. The foundation is undetermined. Exterior walls are original glass curtain wall, brick pier and original brick. The building has a flat with parapet roof. Windows are original steel, 1/1 double-hung sashes. A COMPLETE RESTORATION
