HISTORIC RESOURCE INVENTORY FORM

**318 Elm St
Abilene Texas 79601 United States**

Historic name: Fulwiler/Smith House

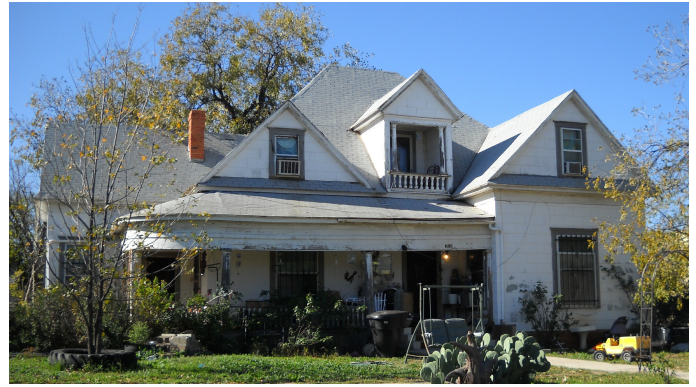
This is a 1.5-story, 3-bay domestic building in the Eastlake/Queen Anne style built in 1884. The structural system is frame. The foundation is undetermined. Exterior walls are original wood siding. The building has a multi-plane front gable roof clad in replacement asphalt shingles with box cornice and one gabled dormer. There is one offset left, front slope, brick chimney. Windows are original wood, 1/1 double-hung sashes. There is a wrap-around open porch characterized by a shed roof clad in asphalt shingles with classical wood posts. Gable Dormer with small balcony on front. Underwent repairs in 2012 due to a fire.
