HISTORIC RESOURCE INVENTORY FORM

Resource Address:
1434 Hickory St
Abilene Texas 79601 United States

Historic name: Mcbridge/Alcantar House

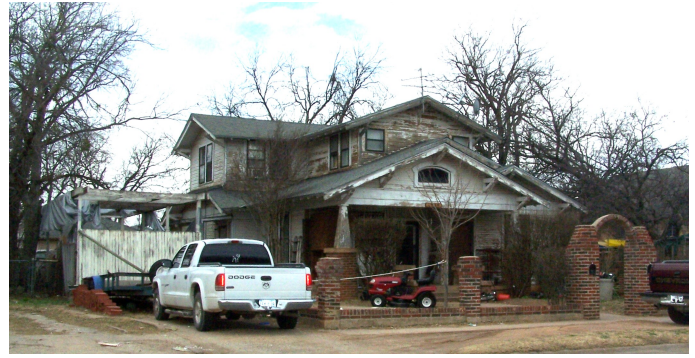
This is a 2-story, 4-bay domestic building in the Craftsman style built in 1920. The structural system is frame. The foundation is undetermined. Exterior walls are original wood siding. The building has a multi-plane front gable roof clad in replacement asphalt shingles with raked open cornice, exposed rafters and brackets and two gabled dormers. There is a single-story, three-quarter open porch characterized by a gabled roof clad in asphalt shingles with short battered wood posts on square brick piers.
