HISTORIC RESOURCE INVENTORY FORM

Resource Address:
768 Mulberry St
Abilene Texas 79601 United States

Historic name: Horn/Turner House

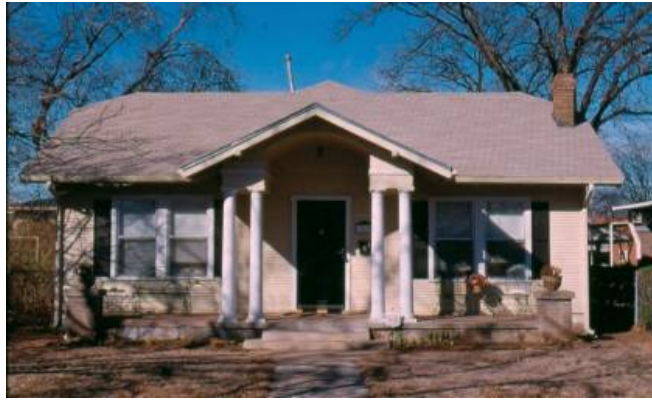
1997

This is a 1-story, 3-bay domestic building in the Colonial Revival style built in 1926. The structural system is balloon frame. The foundation is undetermined. Exterior walls are original wood siding. The building has a clipped hip roof clad in replacement asphalt shingles with box cornice. Windows are replacement vinyl, 1/1 double-hung sashes. There is a single-bay open porch characterized by a gable with arch roof clad in asphalt shingles with classical wood posts.
