HISTORIC RESOURCE INVENTORY FORM

Resource Address:
1482 N 1st St
Abilene Texas 79601 United States

Present name: Old Weather Building

Survey and Recorder		
Project: City of Abilene - Historic Buildings and Districts	Sequence/Key no.: 154	Survey Date: 2/2012
Prepared By: Abrigg	Report Title/Name: Texas SHPO Grant to update existing Survey	Previous Surveys:
Inventoried: 10/22/2012 11:43:40 am Last updated: 04/18/2017 4:13:47 pm by Hayden Brodowsky /	Level of Survey: <input checked="" type="checkbox"/> Reconnaissance <input type="checkbox"/> Intensive	Additional Research Recommended? <input checked="" type="checkbox"/> Yes <input type="checkbox"/> No

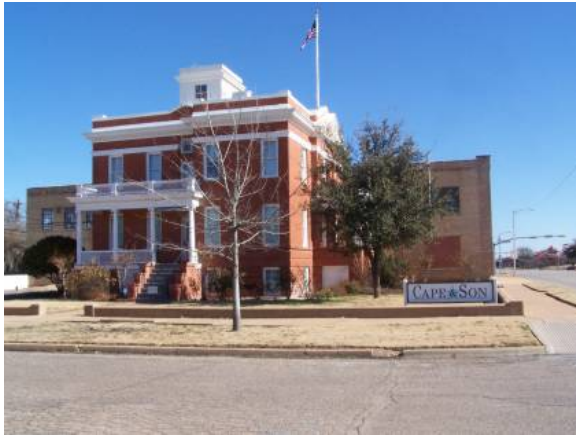
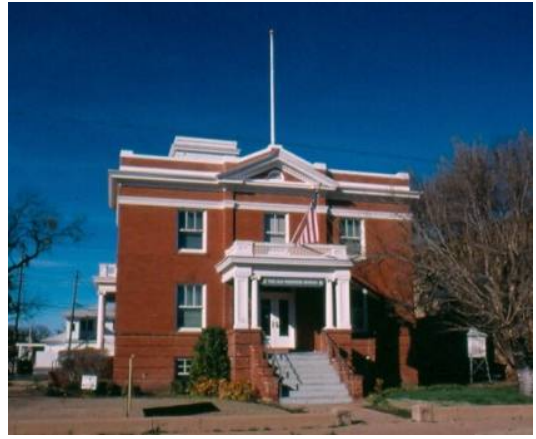
1998

This is a 2.5-story, 3-bay commercial building in the Beaux Arts/Neo-Classical style built in 1909. The structural system is frame. Exterior walls are original brick. The building has a flat with parapet roof. Windows are original wood, 3/1 double-hung sashes. There is a single-story, single-bay portico characterized by a flat roof clad in an undetermined material with paired wood posts.

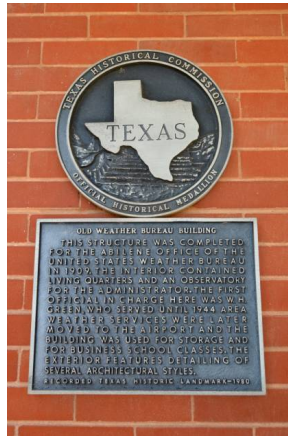
Historical marker on the Old Weather Bureau Building
