HISTORIC RESOURCE INVENTORY FORM

**1546 N 2nd St
Abilene Texas 79601 United States**

Historic name: James House

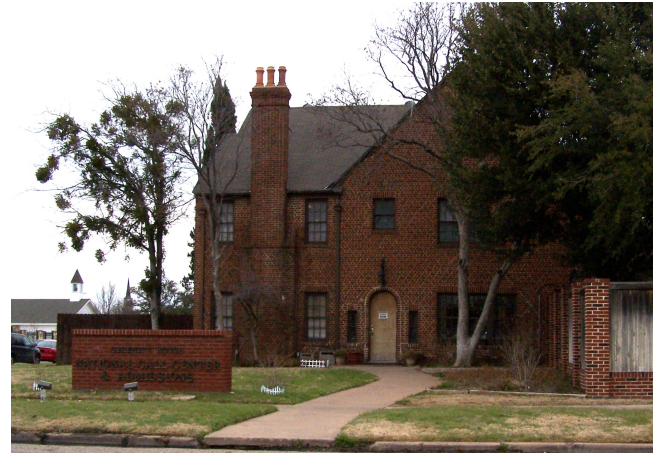
This is a 2.5-story, 2-bay domestic building in the Tudor style built in 1930. The structural system is frame. The foundation is undetermined. Exterior walls are original brick. The building has a cross gable roof clad in replacement asphalt shingles with flush eaves. There is one off center in front, exterior, brick chimney. Windows are original wood, 6/6 double-hung sashes. There is a platform/stoop. Very large addition on the eastern side that could potentially be removed. It is very evidently a later addition.
