HISTORIC RESOURCE INVENTORY FORM

Resource Address:
858 Sayles Blvd
Abilene Texas 79601 United States

Historic name: Dillor House

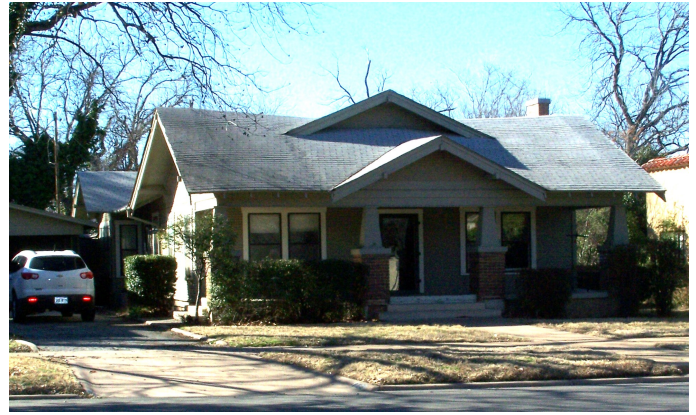
This is a 1-story, 3-bay domestic building in the Craftsman style built in 1928. The structural system is frame. The foundation is undetermined. Exterior walls are original wood siding. The building has a cross gable roof clad in replacement asphalt shingles with open cornice , exposed rafters. There is one offset right, rear slope, brick chimney. Windows are replacement vinyl, 1/1 double-hung sashes. There is a full-span open porch characterized by a gabled roof clad in asphalt shingles with battered wood posts on square brick piers.
